Common Installation Failures: Why Things Go “BOOM” in the Night

by Sally Grambusch
3M

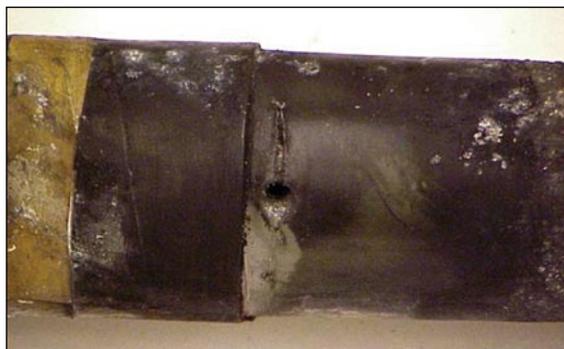
Two separate splice installations received from the same customer. One body had failed; the other body had not failed but was cut out for investigative purposes.

Figure 1a — Photo a ring cut just beyond semiconductor step on failed splice installation.

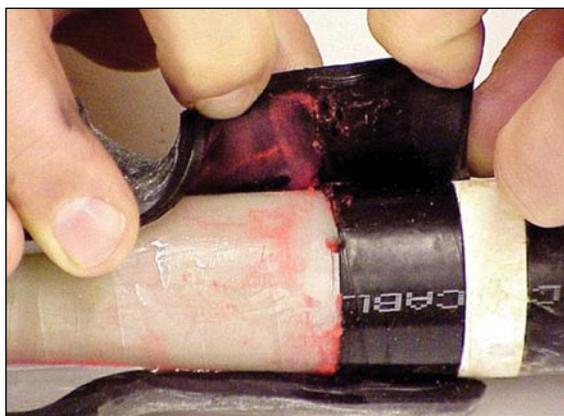
Figure 1b — Photo shows a ring cut on the unfailed splice installation. This installation was in service although it was in the process of failing.

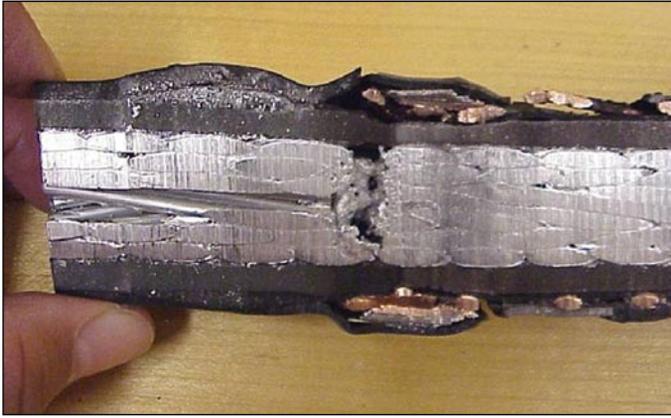
Figure 2 — JCN neutrals were cinched in place beneath the constant force spring portion of the ground strap in a termination installation. The ends of the neutral wires pressed into the cable insulation and created a stress point which eventually created a hole in the insulation and failure upon reaching the conductor.

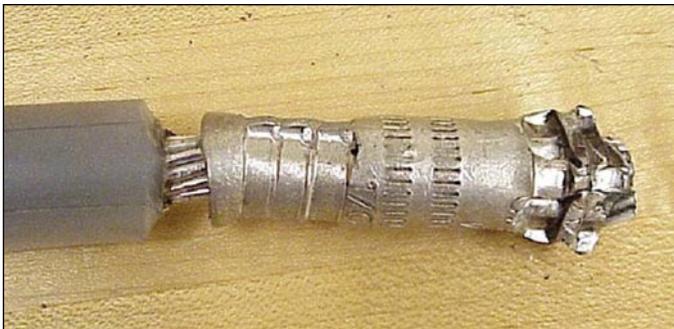
Figure 3 — Poor crimping technique either from using the wrong die or poorly calibrated crimping tool.

- Poor connector crimps. Though a number of different problems can surface as a result of incorrect crimping, one of the most common issues is increased electrical stress on the connector itself. This can cause the connector to produce an increased amount of heat distress and can result in the thermal heating of the cable insulation. Depending on the type of cable, thermal heating can cause the cable insulation to soften and flow, much like candle wax.
- Improper cleaning of the cable insulation. In this case, any foreign substance left on the cable insulation, such as specs of semiconductor material or dust from sanding of the cable insulation, can cause tracking and may eventually degrade the cable to the point of failure.

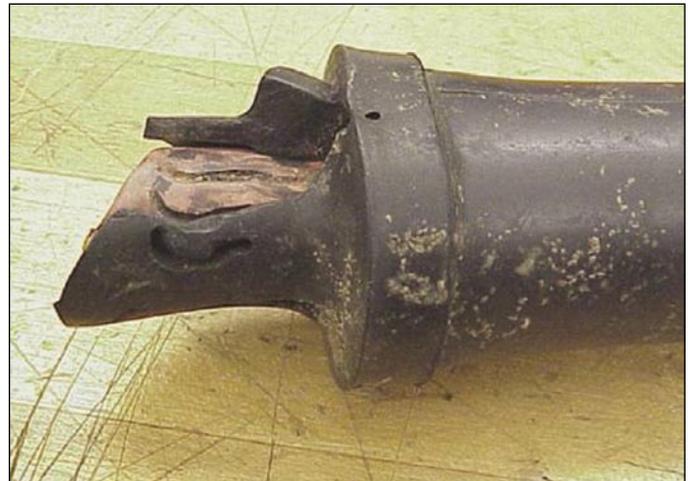
Figure 4 — Splice installation that failed due to termites burrowing tunnels through the splice body and into the cable insulation.

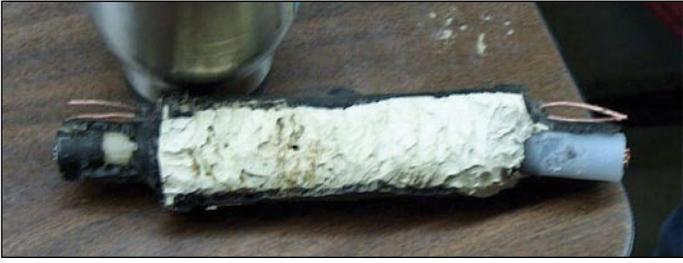
Figure 5 — Failed splice installation due to beaver damage.

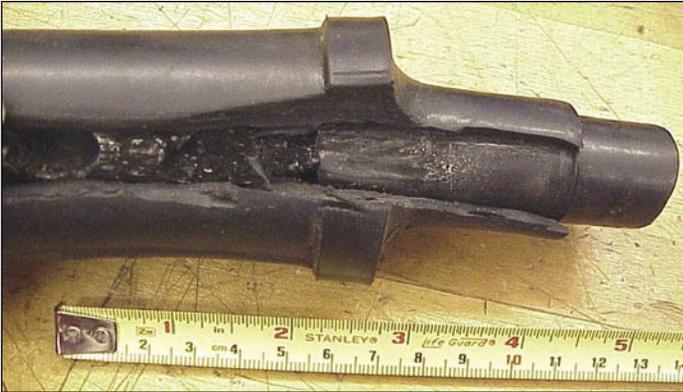
Figure 6 — Evidence of failure due to thermal heating. Cable insulation has melted which led to insufficient contact between cable insulation and interior of splice body. This installation was also misaligned on the cable.
