Top Five Switchgear Failure Causes and how to avoid them

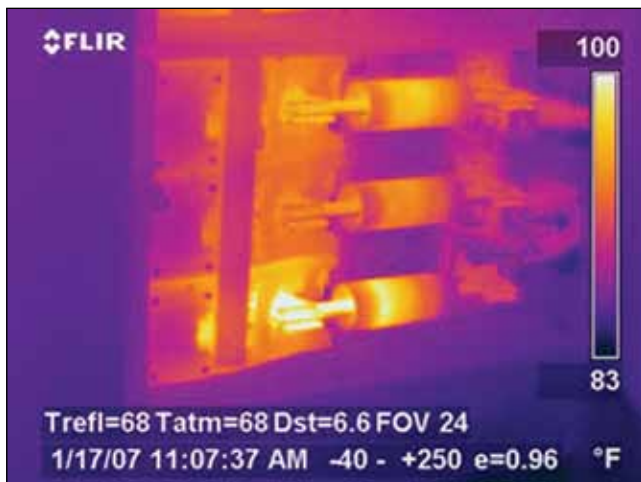
Figure 1 — Hot Fuse Connection

The solution to avoiding these types of failures is to perform regular infrared inspections of all switchgear. Infrared viewing ports should be installed and medium-voltage switchgear should have ports that also pass ultraviolet light so that corona cameras can be used to inspect for corona and surface partial discharge activity. Figure 1 shows a thermal image of a loose switchgear connection that could lead to future failure if not repaired.

Loose and faulty connections cause an increase of resistance at that localized point. The increased resistance causes increased heat in accordance with Ohm's law, $P = I^2R$. The increase in heat will escalate until complete thermal failure of the connection occurs or the nearby insulation fails resulting in a fault. One major insurance carrier estimates that approximately 25 percent of all electrical failures occur due to loose connections.

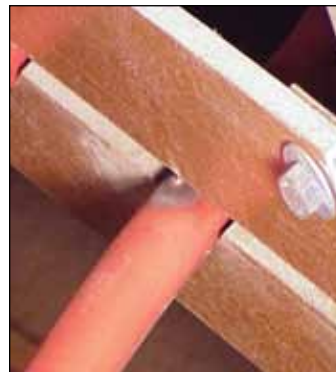
Figure 2 — Unshielded Medium-Voltage Jumper Cable

- a. Jumper cables – Unshielded jumper cables are used to connect switches to transformers in unit substation design; connect potential transformers, control power transformers, and surge arresters to the bus; and connect transformer coils and taps together. Anytime these cables come in contact with ground, other phases, or even other

types of insulation used to support them, they will likely develop stresses at those points that will lead to future failure (see figure 2).

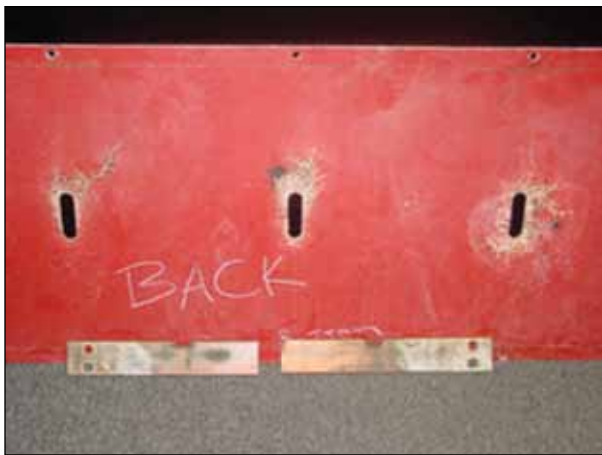
Figure 3 — Switchgear Bus Support Barrier

- b. Bus – Most switchgear designs use simple insulation barriers to separate compartments and to support the bus. These barriers often have small air gaps between the bus and insulation. The localized voltage stress is great enough to cause the air to break down and this partial breakdown will lead to eventual failure (see figure 3).

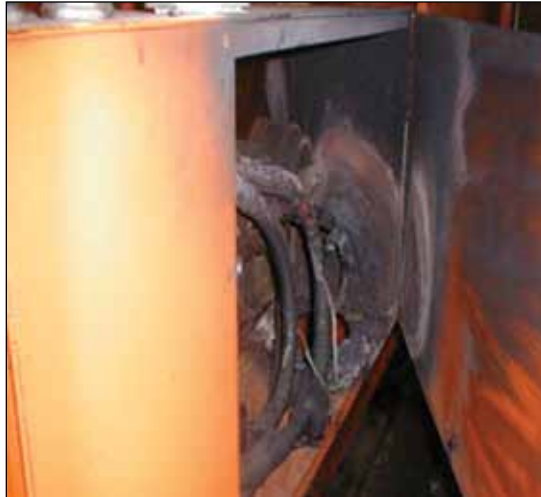
Figure 4 — Termination Failure

- c. Cable terminations – Cable terminations are difficult to build properly. These components transition the shielded cable that has nearly perfect inherent voltage stress control to a connection to the bus. Many things can go wrong if great care is not taken during the termination construction, and the proper voltage stress relief details are not realized. Additionally, the portion of the termination nearest to the connection essentially consists of unshielded insulation, so care must be taken to ensure

adequate clearances in that area. All of these locations within the termination can create localized partial insulation breakdown that will lead to failure (see figure 4).

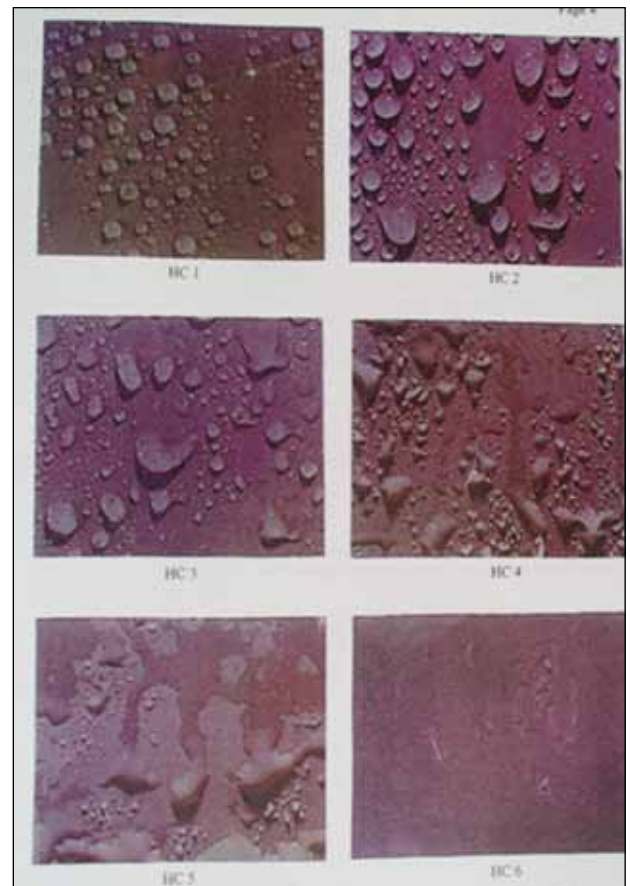
Water intrusion or immersion due to natural disasters or accidents can create instant short circuits, long term insulation damage, and long term metallic component corrosion, among other complications. Medium-voltage switchgear that is exposed to high humidity conditions will absorb moisture, and voltage stresses will attack the hydrophobic insulation surfaces which were designed to inhibit moisture absorption (see figure 5).

Figure 5 — The upper left photo shows good insulation with hydrophobic surface qualities that progressively worsen until the insulation becomes hydrophilic in the lower right photo due to voltage stresses.

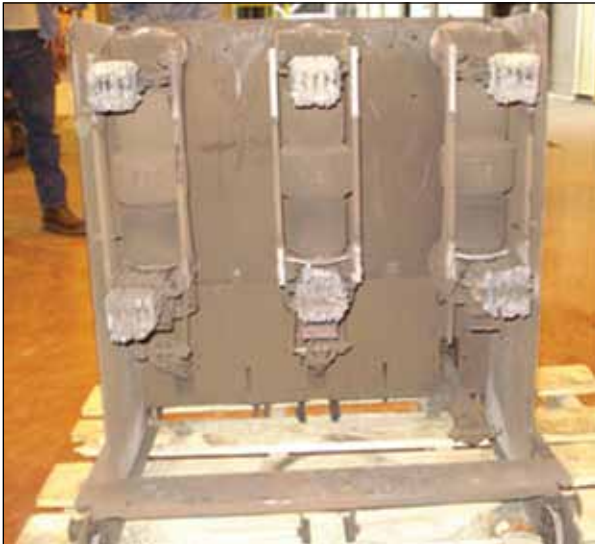
Racking in a closed circuit breaker onto an energized bus can quickly cause severe personal injury or death and immediate severe equipment damage (see figure 6). Additionally, the breaker may not always line up properly or may encounter other difficulties as it is being racked, and these problems can cause a sudden severe fault. Unfortunately, the traditional act of breaker racking requires personnel to manually perform this task directly in harm's way.

Figure 6 — Severe Breaker Damage Caused by Improper Rack-In Operation

The solution to this problem is to always make sure that mechanical and electrical interlocks are functional and all breaker and cell components are properly inspected and serviced. To ensure personnel safety, strong consideration should be given to employment of a remote circuit breaker racking device such as shown in figure 6.

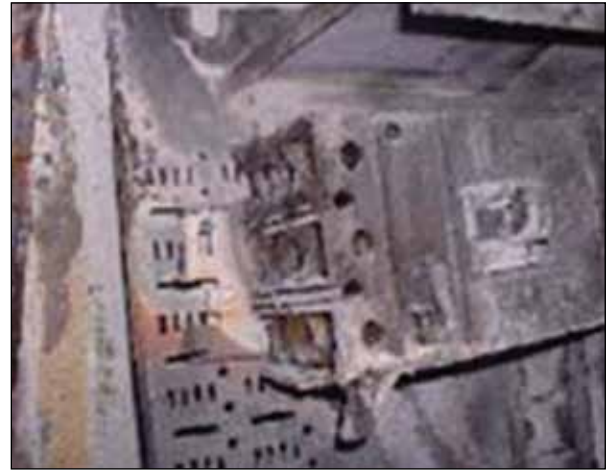
Unlike the items above, a defective ground fault protective device will not create a fault itself. However, it will not offer protection from an arcing ground fault which is a common failure mode in 480Y/277V solidly-grounded switchgear. These types of faults are very destructive but do not draw high enough currents to trip breakers or cause fuses to open and can persist until catastrophic failure of the switchgear occurs (see figure 7).

Figure 7 — Severe Damage from Arcing Ground Fault

The solution to this problem requires an outage and manually testing the ground fault protection system by current injection. Just as important is to pay close attention to ensure that the equipment is properly installed. Sensor polarities must be tested when applicable and the neutral ground connection must be located in the correct position so that the sensors will detect fault currents properly. A list of recommended test procedures can be found in the NETA ATS and MTS standards.
